## VEHICLE INSPECTION REPORT

# ŠKODA SUPERB COMBI

2.0 TDI · DSG · 05/2020 · 156,866 km

An anonymised real-world sample prepared by Car Inspection Austria

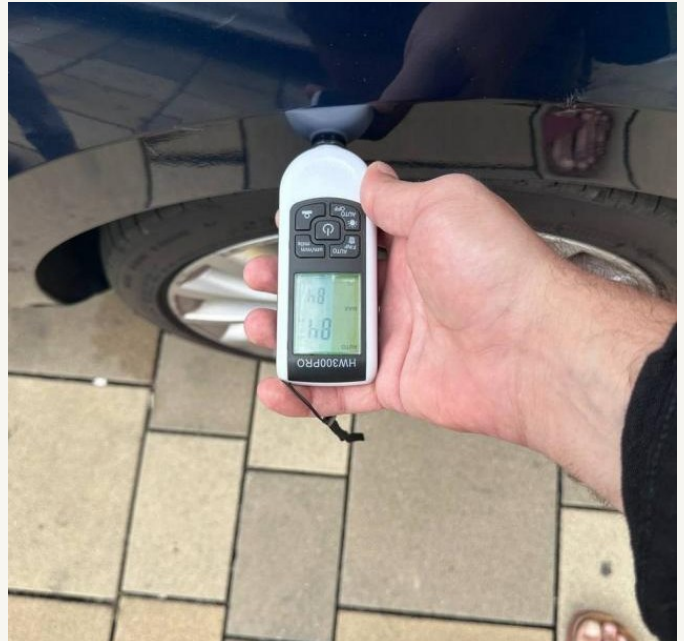
Representative readings were approximately 84–110  $\mu\text{m}$ . No local jumps typical of repainting or filler were found.

84  $\mu\text{m}$

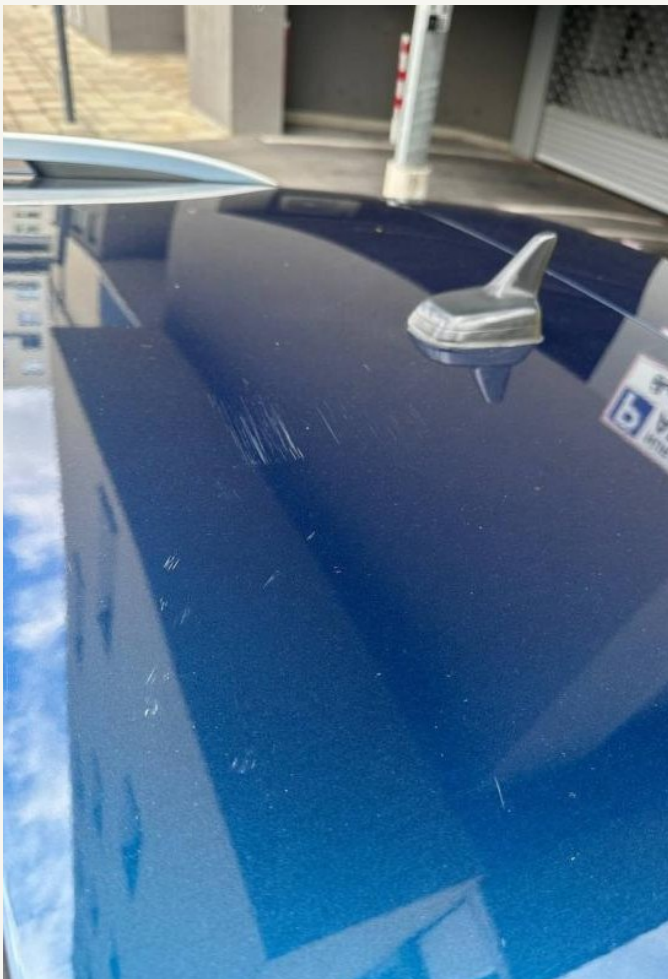
Wash/contact marks on roof

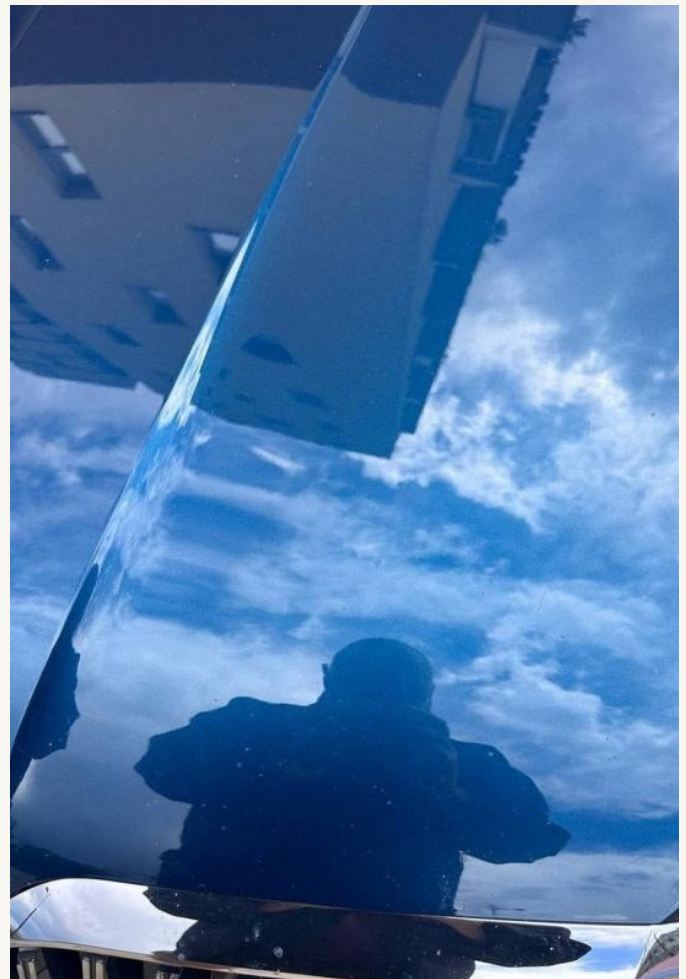
Bonnet chips and use marks

- Replace the rear tyres before a long journey; assess the fronts when choosing the replacement strategy.
- Check the right front seat ventilation at every level, clear the archived code and scan again.
- Clean the panoramic-roof drains as a preventive measure.
- After purchase: deep-clean the interior, condition the leather, polish the body once and touch up bonnet chips.

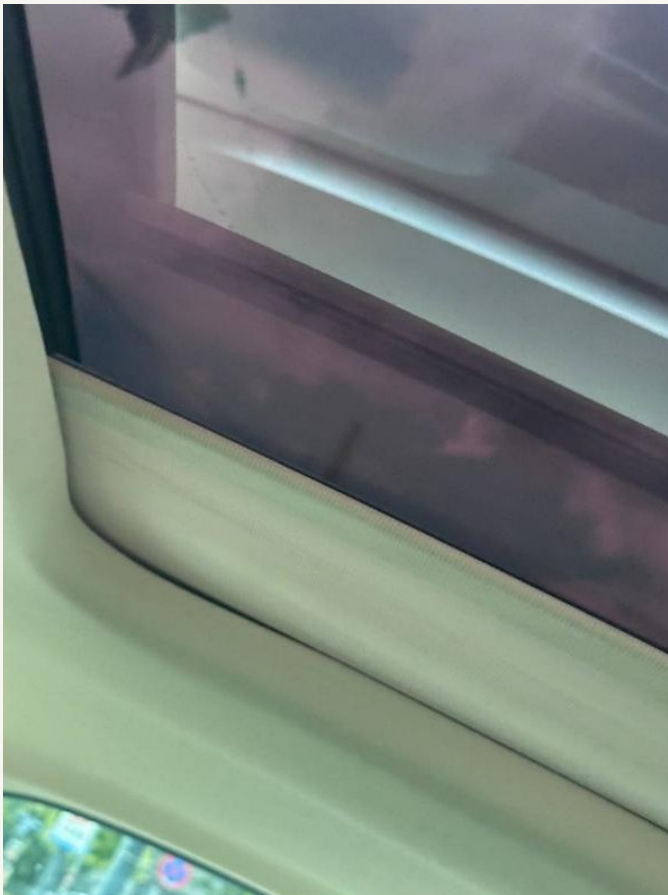
A local dried mark was visible at the front of the blind/headliner. It was dry during the inspection. No similar tracks or current moisture were found at the frame corners, pillars or adjacent areas. The seller's explanation — water entering during a wash with the roof open or tilted — is technically possible but cannot be proven without a controlled water test. No evidence of a systematic leak was found at the time of inspection.

Local dry mark

| Area | Status | Finding |
|---|---|---|
| Before payment | ATTENTION | Perform a controlled water test or document that the seller knows of no leak. |

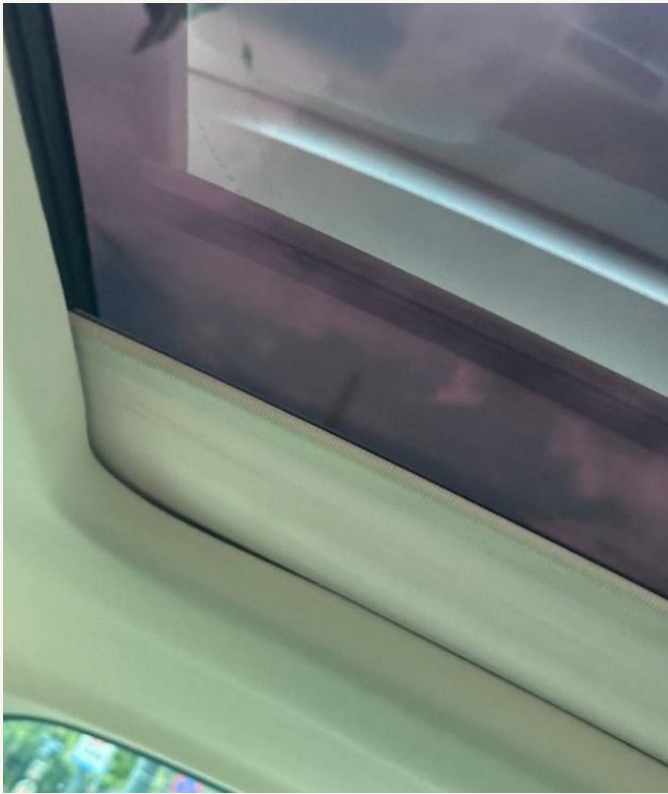
Dry mark at front edge

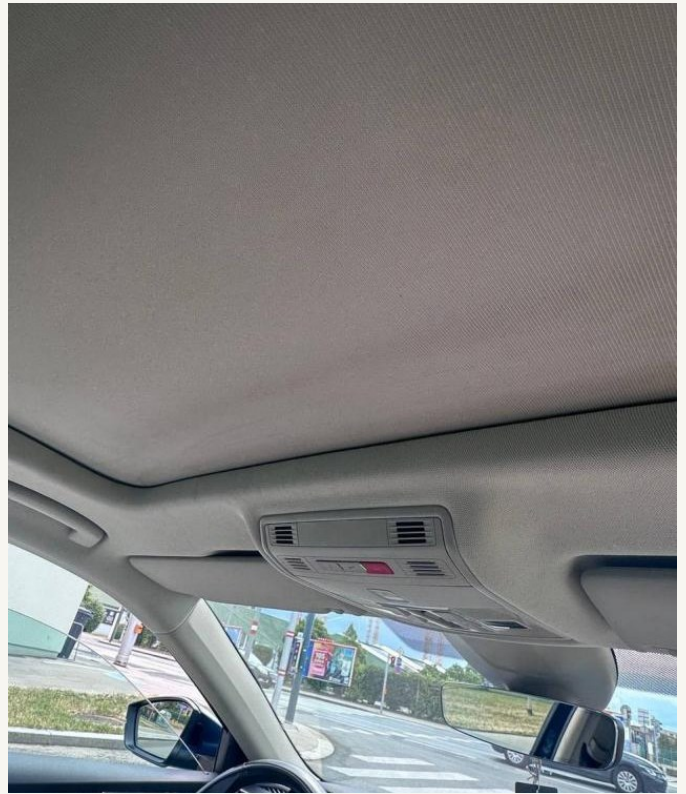
No pronounced corner tracks

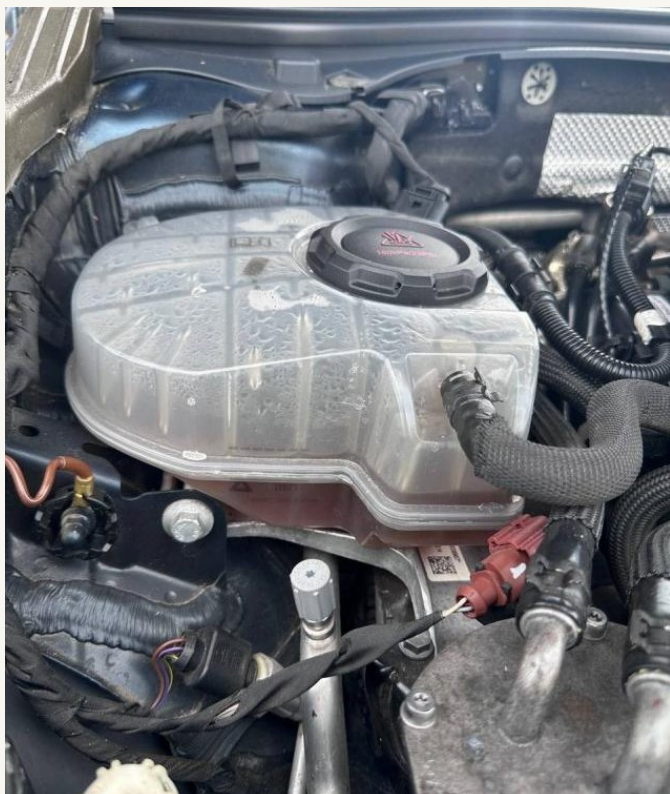
Coolant reservoir and connections: dry

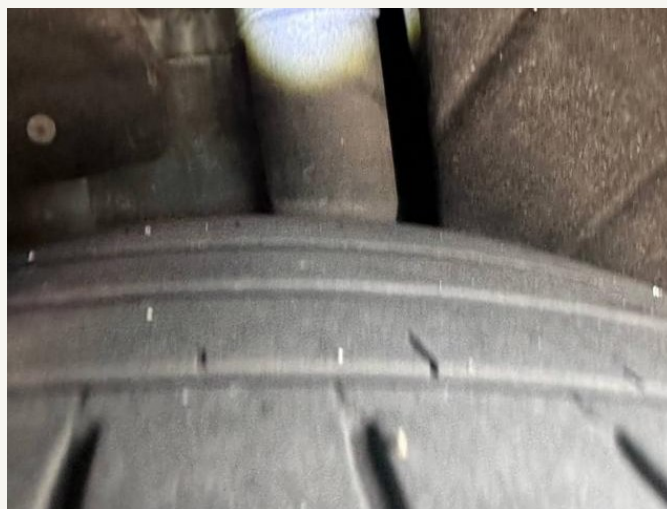
The remaining life of the set was limited. Rear tread was close to the wear indicators and should be replaced before intensive use or a long journey. Remaining depth was assessed visually, not measured in millimetres.

Rear tread near wear indicators

| Area | Status | Finding |
|---|---|---|
| Immediately after purchase | REPLACE | Replace rear tyres; assess fronts with the tyre specialist. |

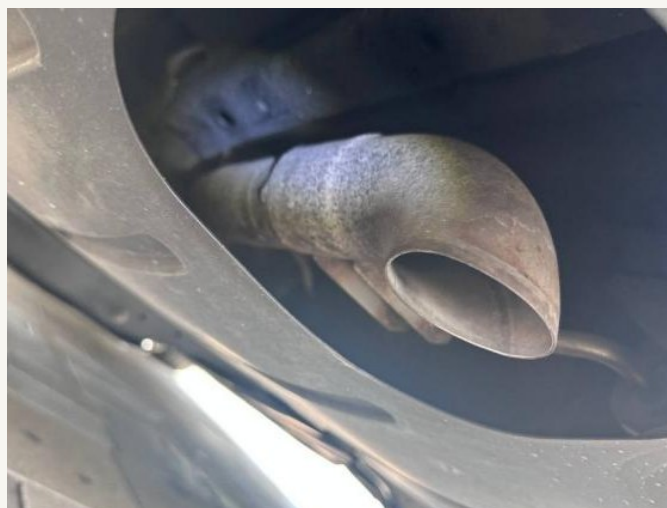
Normal exhaust oxidation

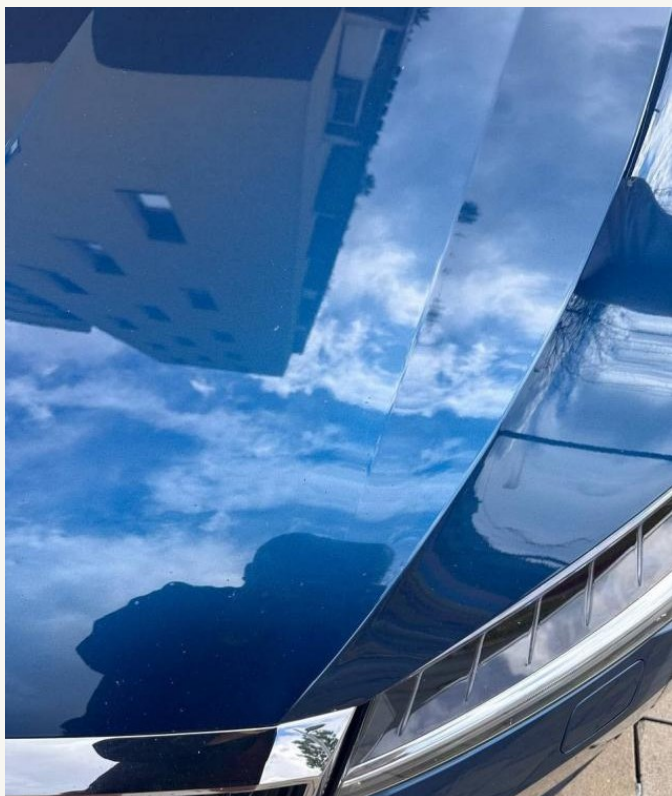
Factory orange-peel texture, no repair waves

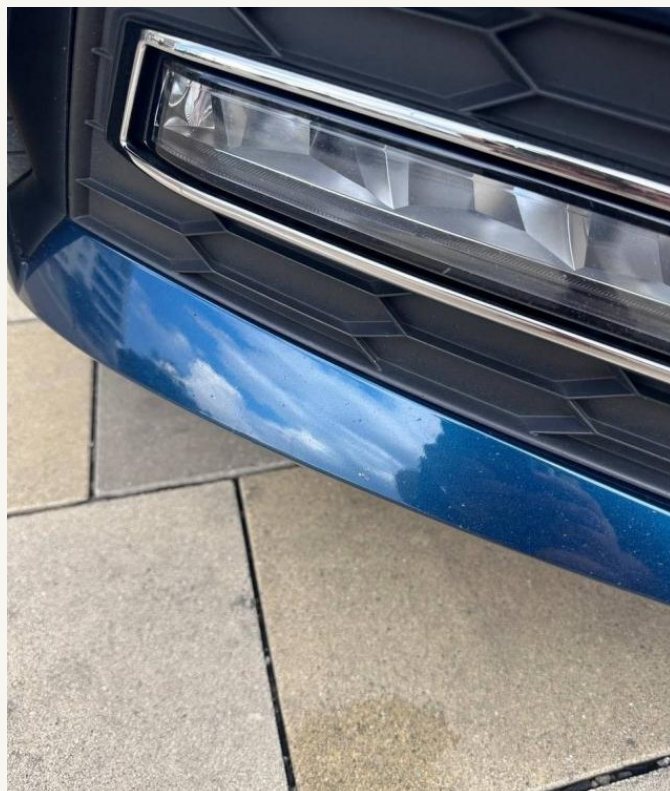
Small lower-bumper chips

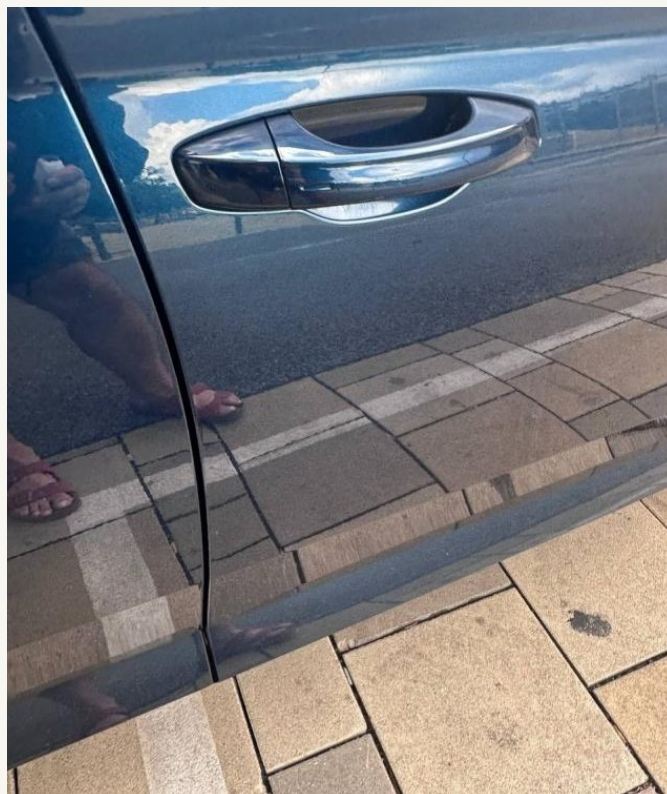
Rear side: cosmetic marks without deformation

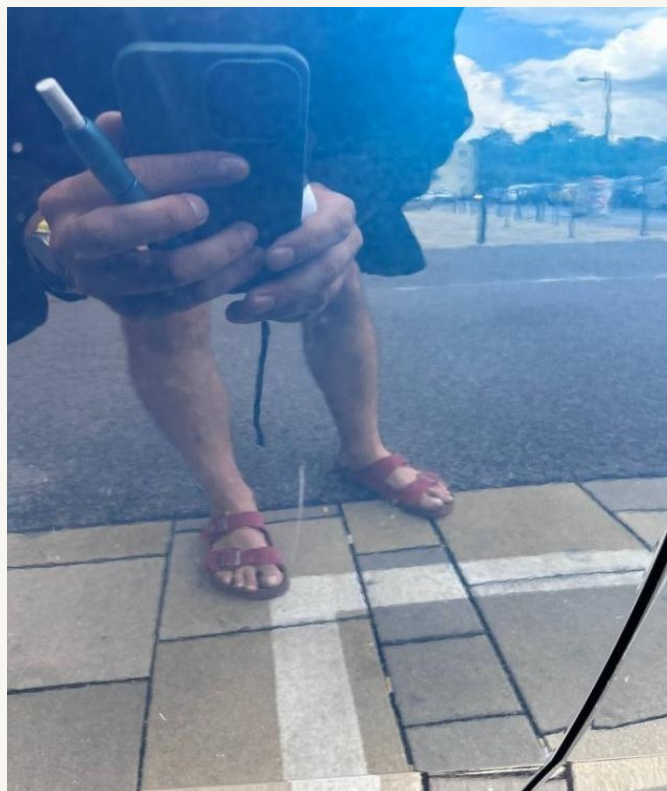
Small lower-door / wing scratch

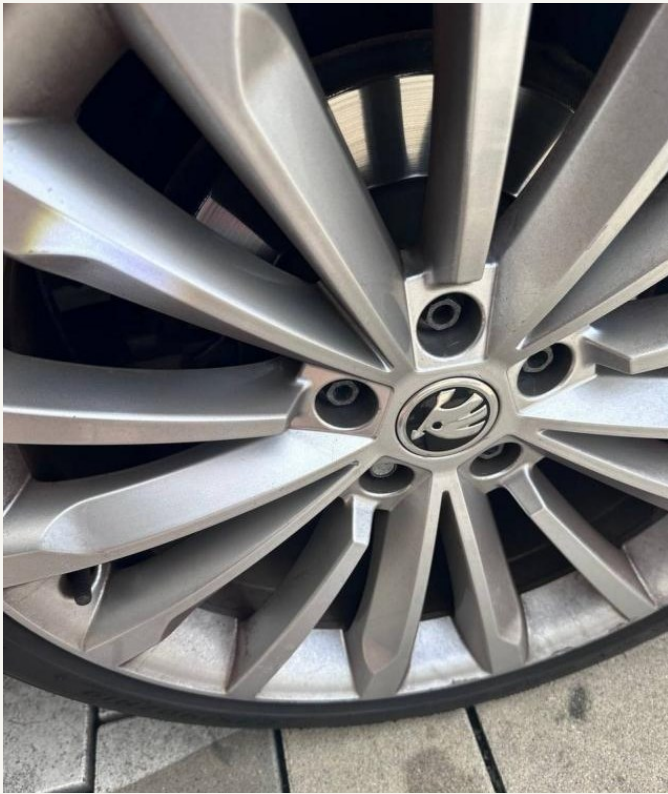
Kerb marks on rim edge

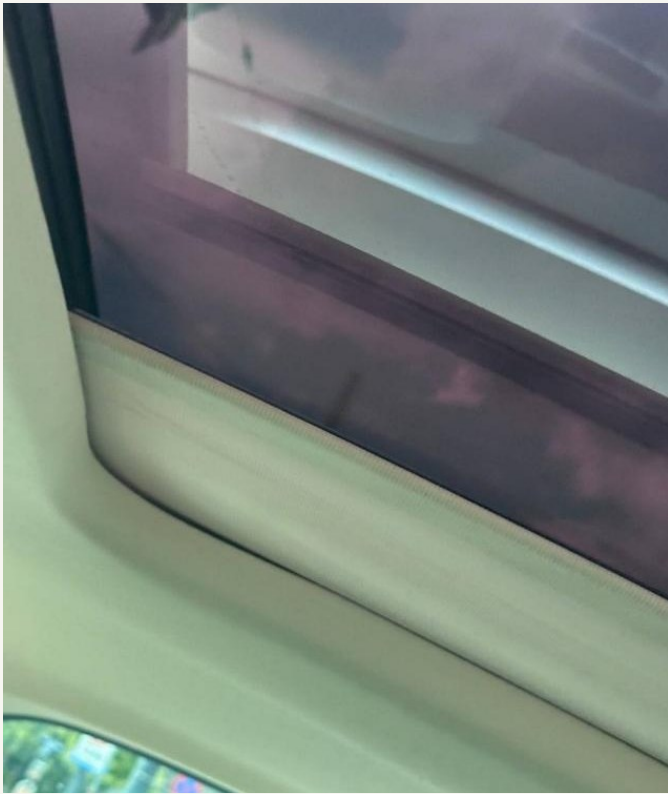
Local dry mark near panorama
