## VEHICLE INSPECTION REPORT

# ŠKODA SUPERB COMBI

2.0 TDI · DSG · 05/2020 · 156,866 km

An anonymised real-world sample prepared by Car Inspection Austria

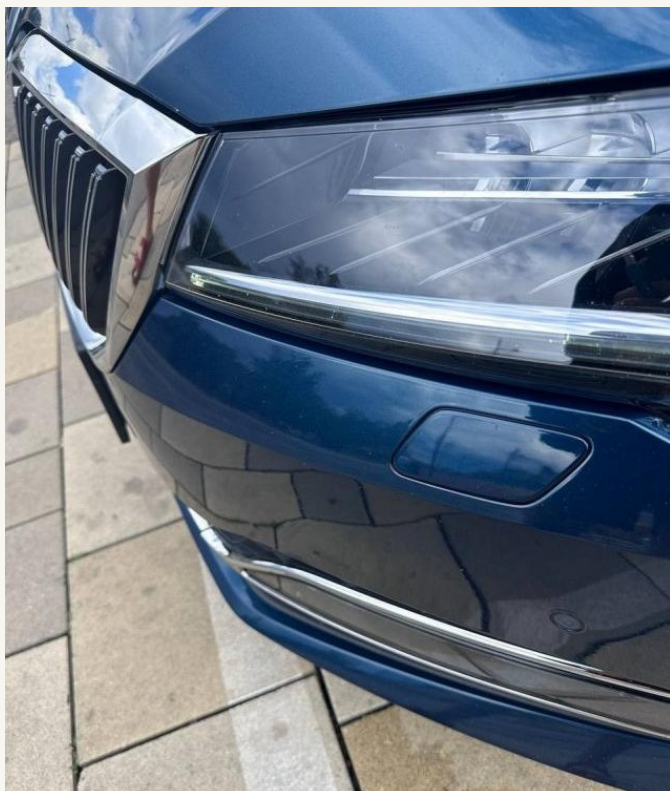
Front light and bumper condition

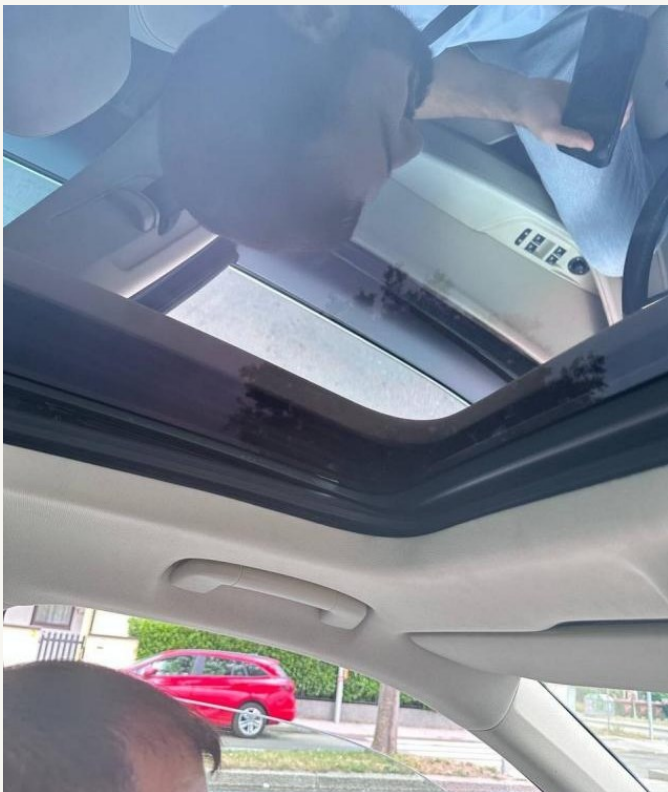
Roof open for frame inspection

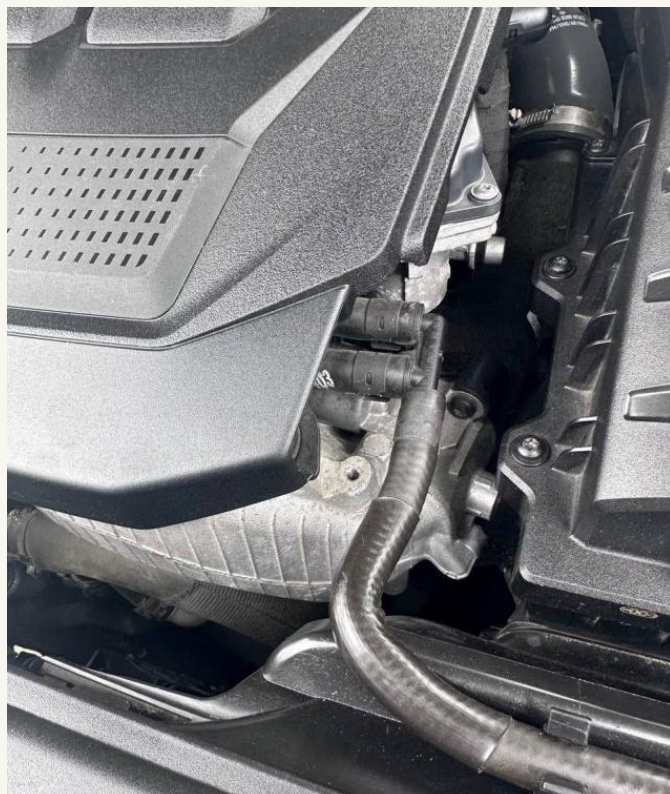
Upper engine and intake

- The engine was warm, ran evenly and followed the relevant commanded values.
- Low DPF pressure at idle and absence of relevant faults do not indicate a blocked filter.
- No fresh oil or coolant leaks were found in accessible areas.
- Implausible universal-app values were excluded from the diagnosis.

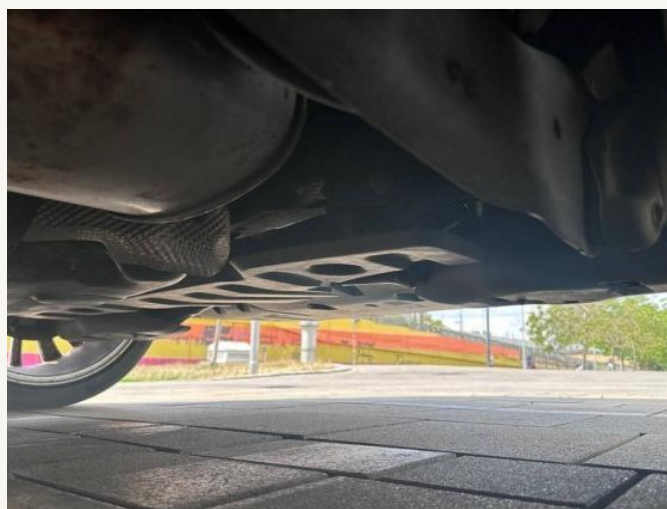
Underbody protection in place

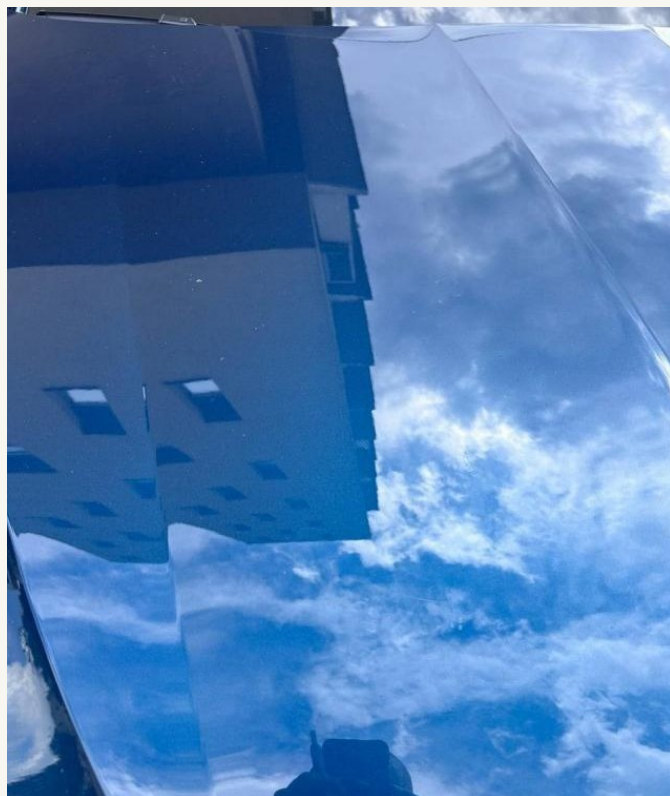
Even colour and gloss

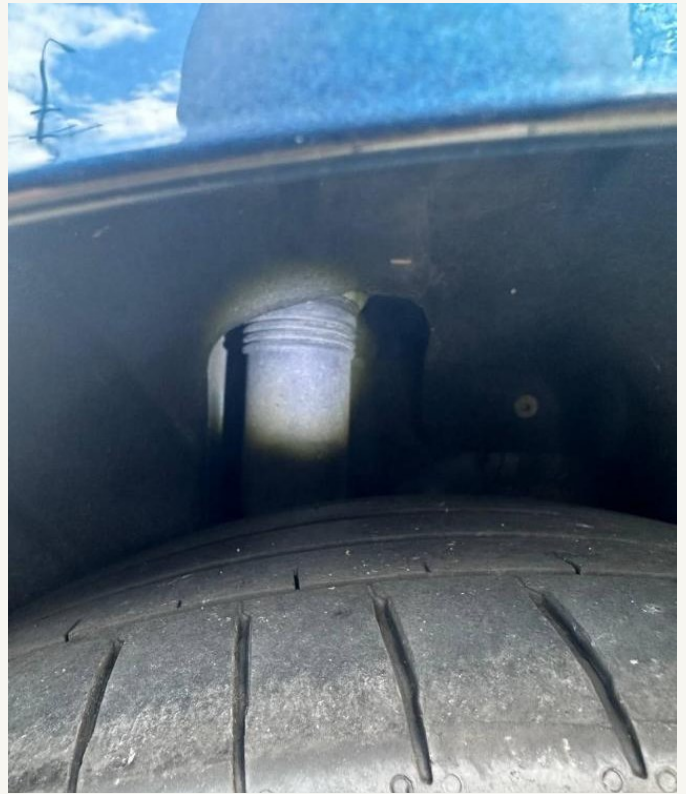
Wheel arch and tyre

The remaining life of the set was limited. Rear tread was close to the wear indicators and should be replaced before intensive use or a long journey. Remaining depth was assessed visually, not measured in millimetres.

| Area | Status | Finding |
|---|---|---|
| Immediately after purchase | REPLACE | Replace rear tyres; assess fronts with the tyre specialist. |

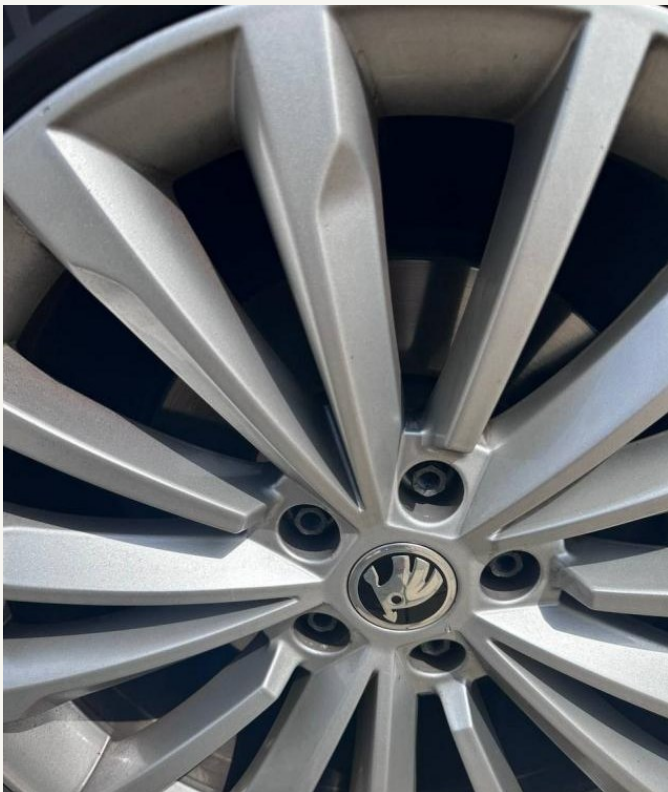
Wheel and brake mechanism

- Working surfaces showed no critical grooves, cracks or pronounced lip; no immediate replacement indicated visually.
- Seller stated the brakes were replaced about one year ago; documentary proof was not checked in this photo report.
- Pad thickness and inner disc faces are assessed more reliably on a lift.
